Draft Report

# INITIAL SITE CHARACTERIZATION AND SUBSURFACE INVESTIGATION REPORT

4TH AND GAMBELL ANCHORAGE, ALASKA

December 1997

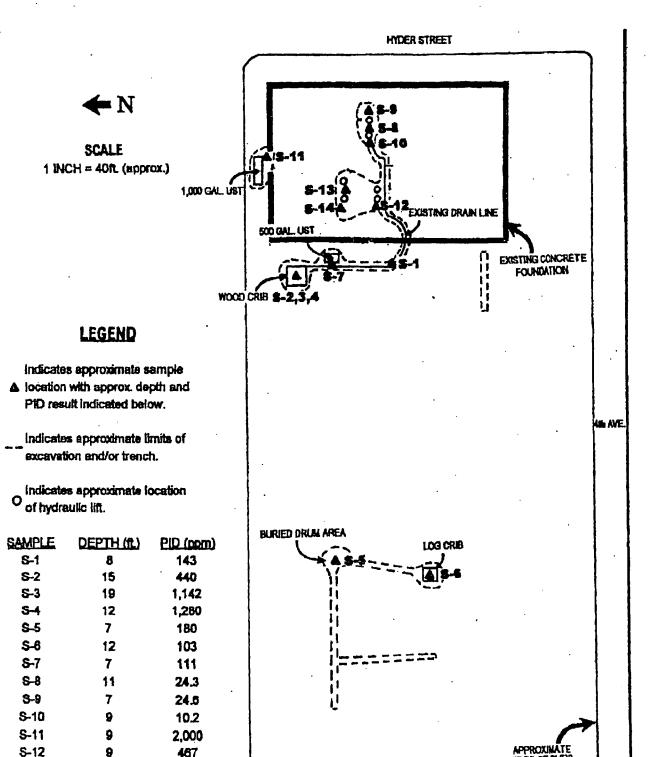
SITE PLAN/SAMPLE LOCATIONS

Seven soil samples were collected and field screened in the areas of the piping and the hoists. The approximate sample locations are shown in Figure 2. The depth of the sample and the corresponding PID reading is also recorded on the Figure. The samples are S-8, S-9, S-10, S-12, S-13, and S-14. The six samples were analyzed by Wy'East Environmental Sciences of Portland, Oregon. The soils were tested for total petroleum hydrocarbon content. The sampling protocol can be reviewed in Appendix F. Tables in Appendix C provide the laboratory results as well as the corresponding PID readings for each sample. The laboratory report can be reviewed in Appendix D.

Soil sample S-7 was collected and field screened using a PID. The sample was collected beneath the 500 gallon tank at approximately 7 feet below ground surface. The location of the sample is shown in Figure 2. The depth of the sample and the corresponding PID reading is also recorded on

Soil sample S-6 was collected approximately 12 feet below ground surface. Soil sample S-6 was collected and field screened using a PID. The location of the sample are shown in Figure 2. The depth of the sample and the corresponding PID reading is also recorded on the Figure. The sample was analyzed by Wy'East Environmental Sciences of Portland, Oregon. Sample S-6 was tested by Wy'East for VOCs by EPA Method 8260 and for metals. The solvent Tetrachloroethylene used by dry cleaning facilities was detected as well as metal contamination.
